Introduction

Methods and Materials

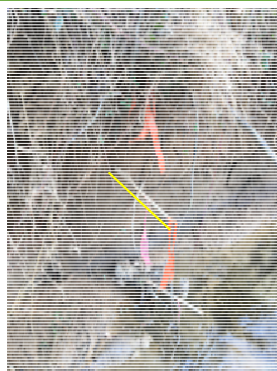
Figure 3 (above left): Displays three bank pins after 28 weeks of exposure at site six of the First Mine Run Game Reserve in White Hall, Maryland. The average exposure of these three pins was 14 inches. The yellow scale bar in the image represents 15 inches.

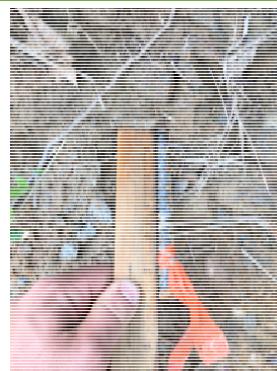
Figure 4 (above right): Displays a researcher measuring the bank pin exposure of the middle pin at site seven of the Beetree property in Freeland, Maryland. This particular pin was exposed 5 ¾ inches 12 weeks after it was installed.

After all of the bank pins were measured (as shown in figure 4) and analyzed, we related thirty five BeHi and NBS ratings to thirty-five annual erosion rates. A box plot was created that displayed the differences between moderate BeHi, high BeHi, and extreme NBS because they had sample sizes significant enough to display meaningful results.
